CHAS-333

SWANN HOUSE

INVENTORY FORM FOR STATE HISTORIC SITES SURVEY

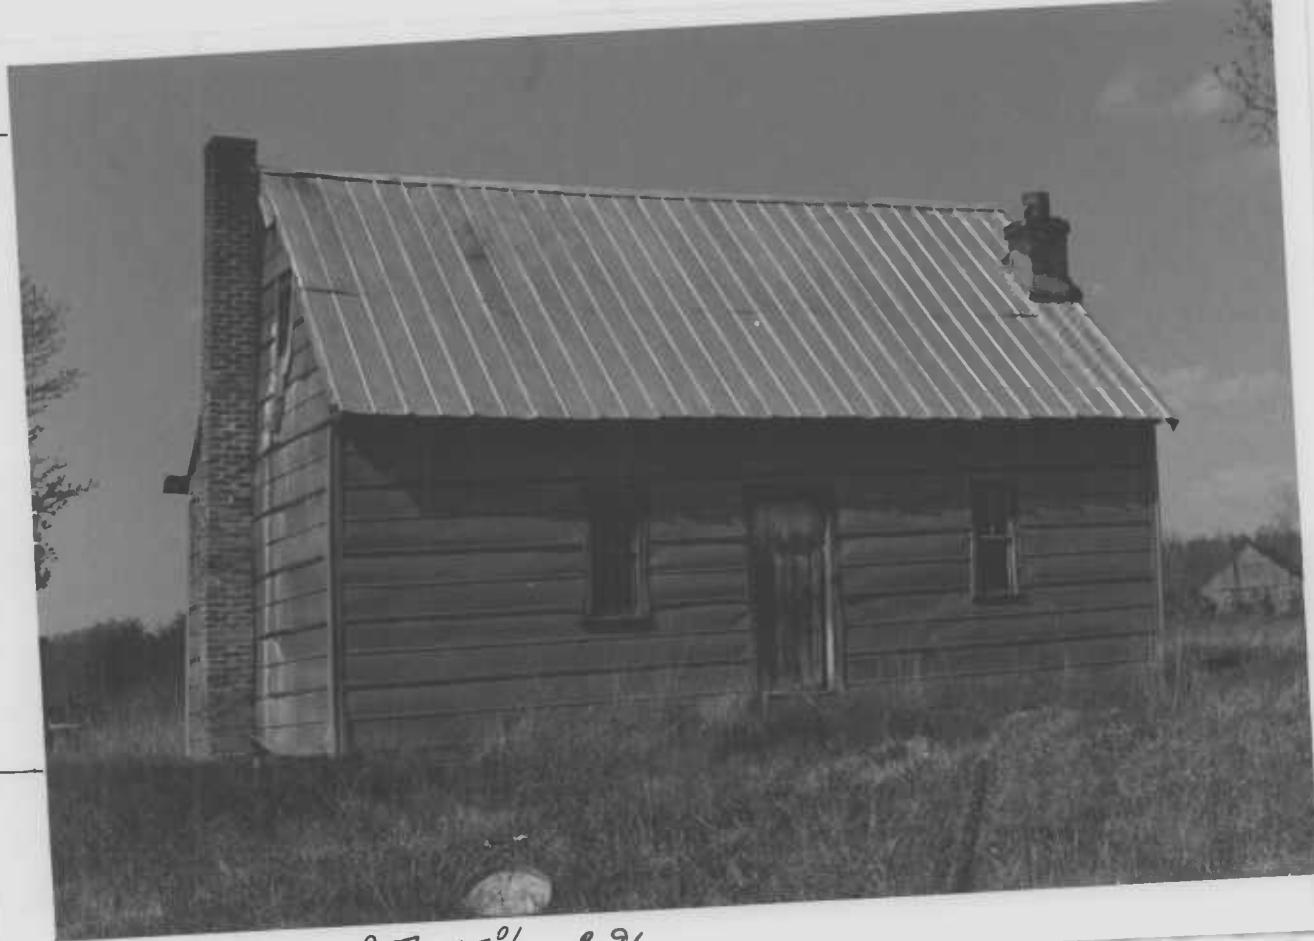
CHAS-333

SWANN HOUSE; East Front.

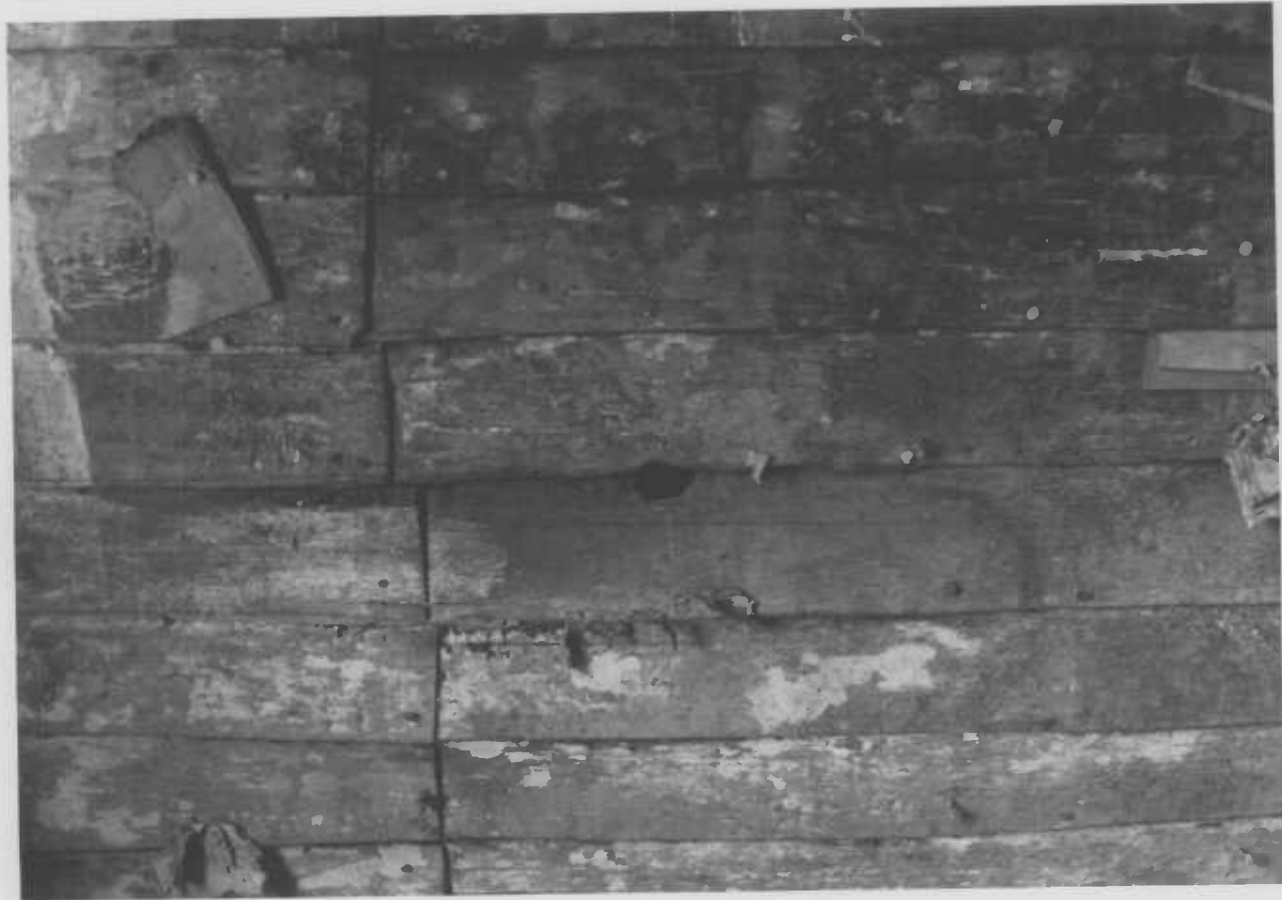
CHAS-333

At a later date the riven boards covering the exterior were removed and some of the boards reused to cover the walls, floor to ceiling, of the northeast first floor room. The original floor was also covered over with planked boards, as were the walls and ceilings of the attic chambers. Both chimneys were replaced with narrow, interior stove chimneys. In more recent years the whole of the exterior, walls and roof, were covered with galvanized tin.

SWANN HOUSE; Interior Clap—
boards. J.R.Rivoire, 1978
